NASA WG3 MMOD Protection Summary

Interagency Space Debris Coordination Committee (IADC)

May 2012

IT 29-1: Hypervelocity Facility CNSA-NASA Cross-Calibration

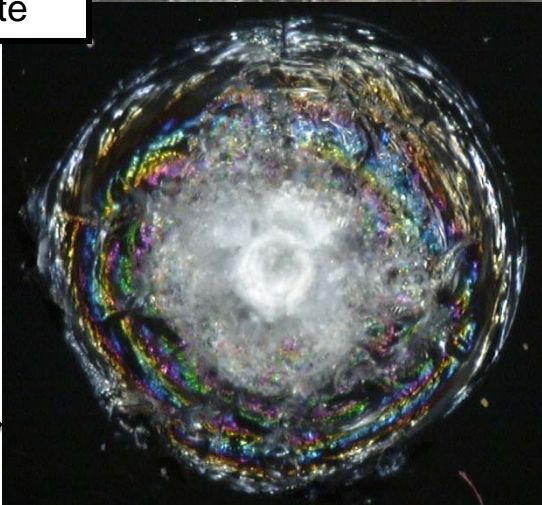
Window 6 →

Number of MMOD Impacts	Largest MMOD Impacts
Windows	7 craters	W6: 2.5 x 2.5 mm damage extent
Radiators	3 MMOD damages reported	1 face sheet perforation
RCC	9 MMOD indications	Panel 9L: 2.3 x 1.9mm, depth = 0.4 mm exposed substrate

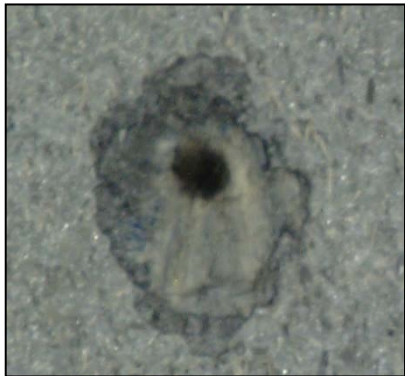
RCC Panel 9L →

Number of MMOD Impacts	Largest MMOD Impacts
Windows	10 craters	W3: 3.7 x 3.5 mm damage extent
RCC	13 MMOD indications	Panel 9L: 1.3 x 1.0mm, depth = 0.27 mm no exposed substrate

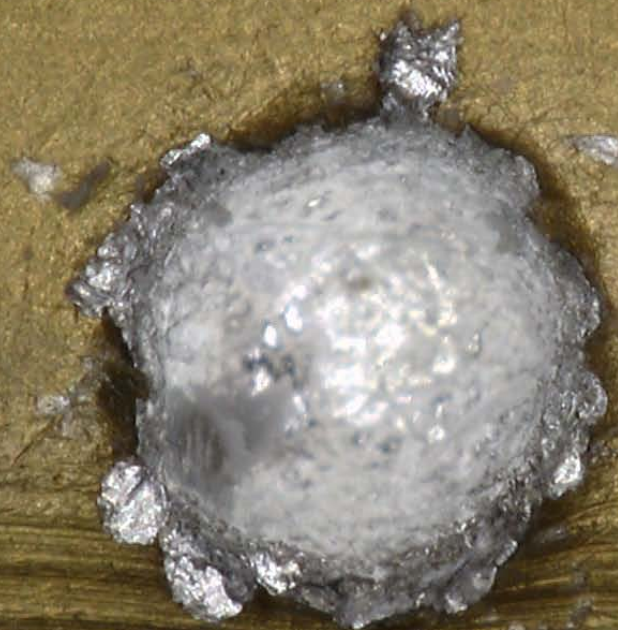
1.8 mm diameter
crater in handrail ZNC7

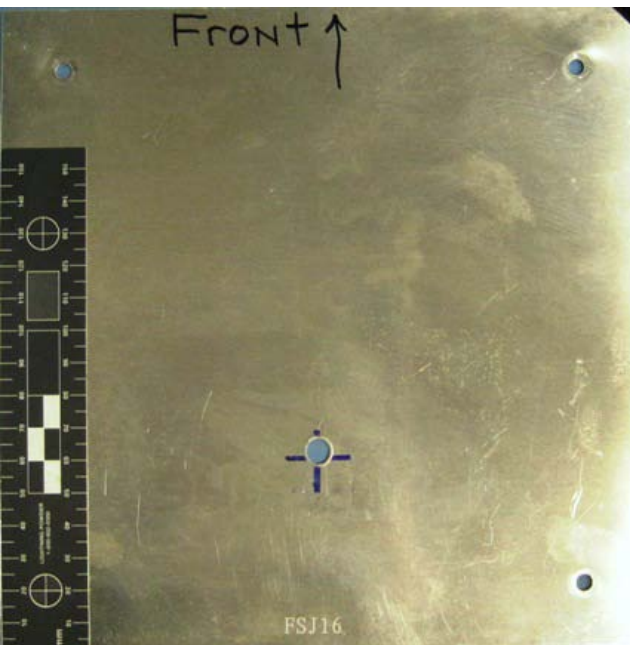
Front

- HITF-11147, 3.2mm AL 2027 projectile, 0.04788g, 5.30km/s, 30deg
 - **1st layer:** through-hole 7.5 x 6.9 mm inside diameter, 9.2 x 8.4 mm outside diameter (including crater lips)
